Inspection Photos

I00090053+07231

Location 10 KM E SUPERIOR Stucture Name: none

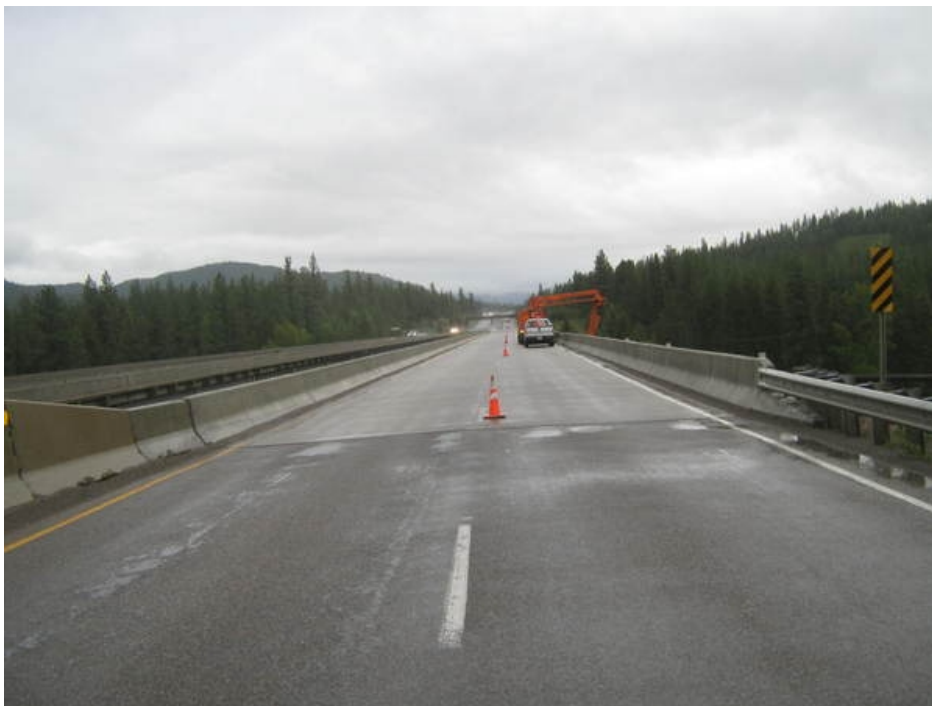
AOL **Notes**

Aol and looking east, left is upstream.

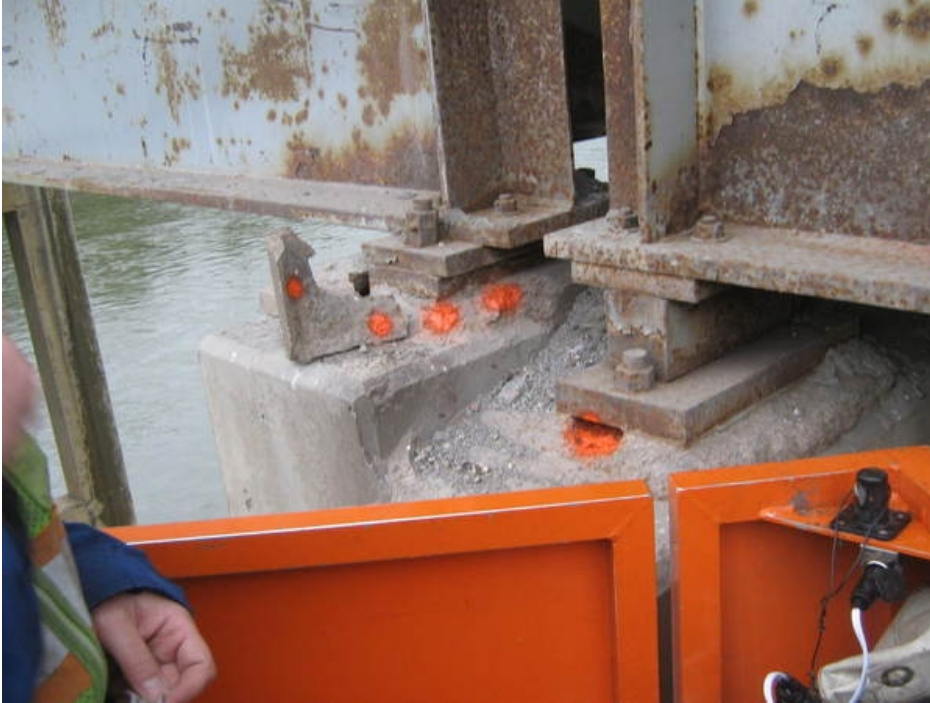
Bent 2 Grout Pads

The grout pad at bent 2 continue to deteriorate with loss of section.

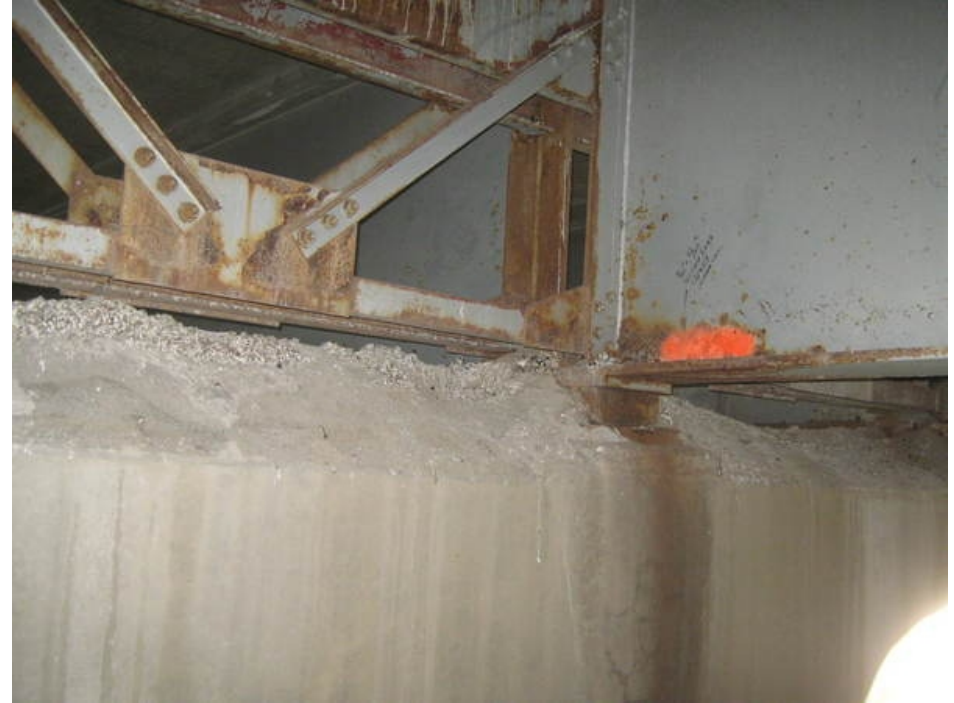
Cap Bent 2

The cap at bent 2 needs the sanding material cleaned off the cap and from around the bearings.

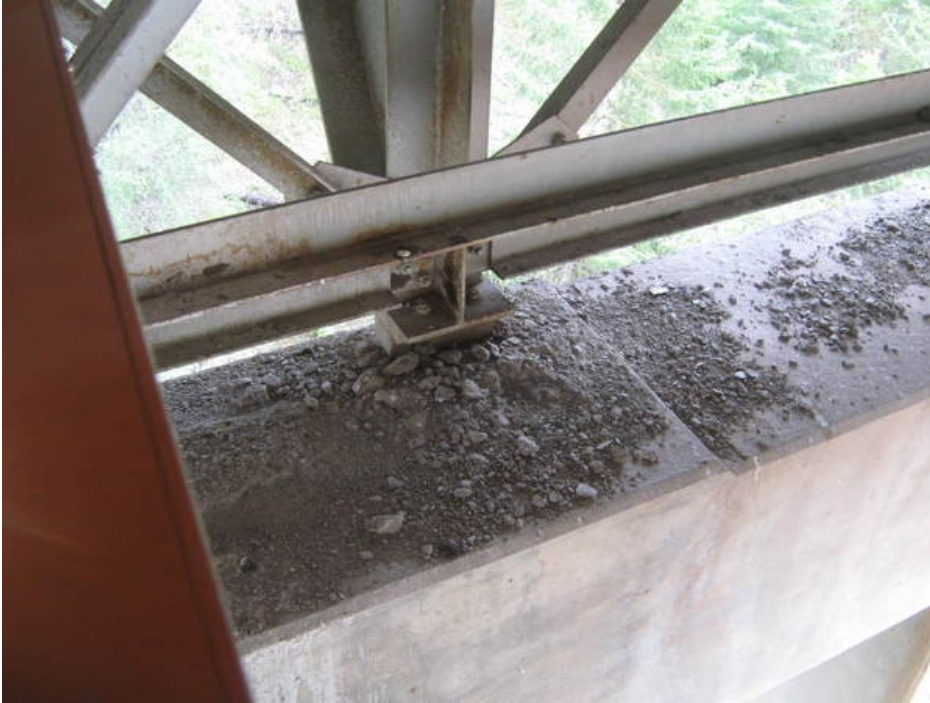
Cap bent 6

The material on the cap and around the bearing needs cleaned off.

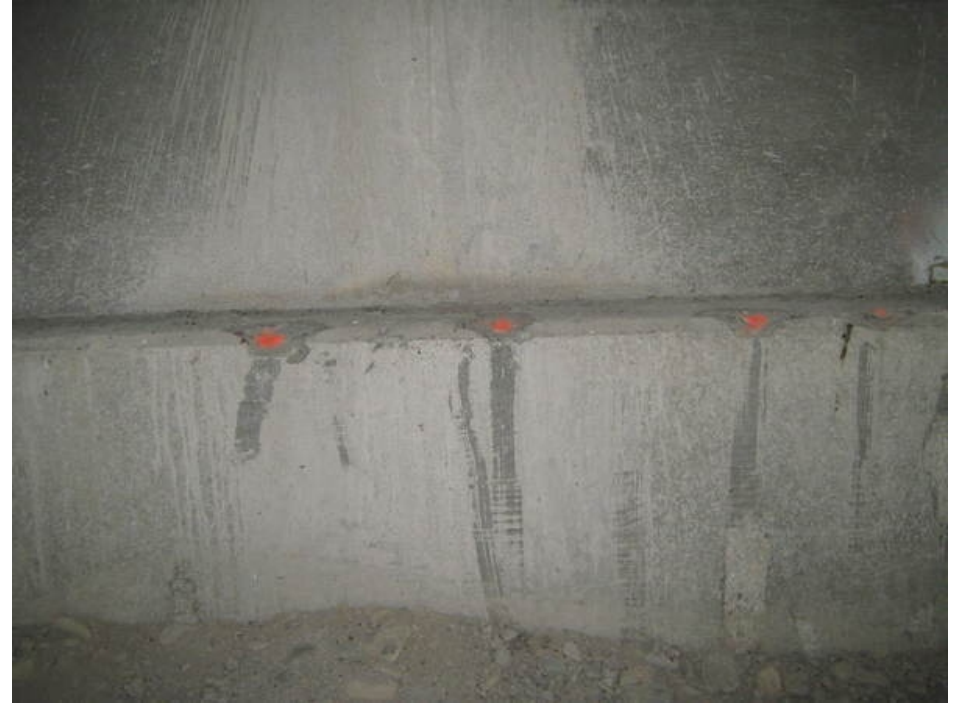
Bent 1 Cap

Minor spall on the cap at bent 1.

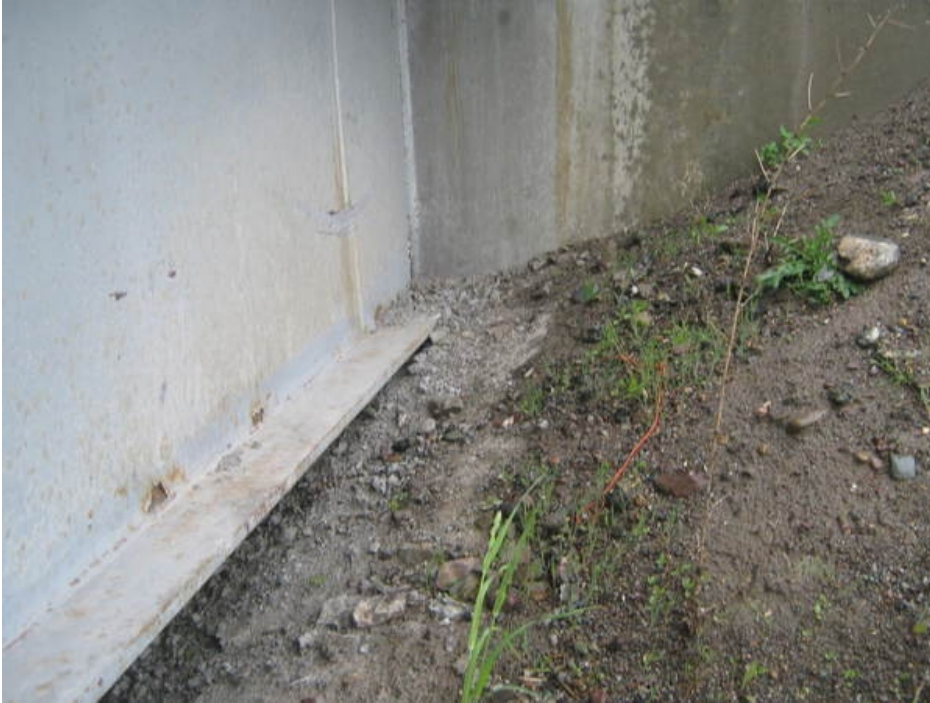
Abutment 8

Clean the material off the caps at both abutments.

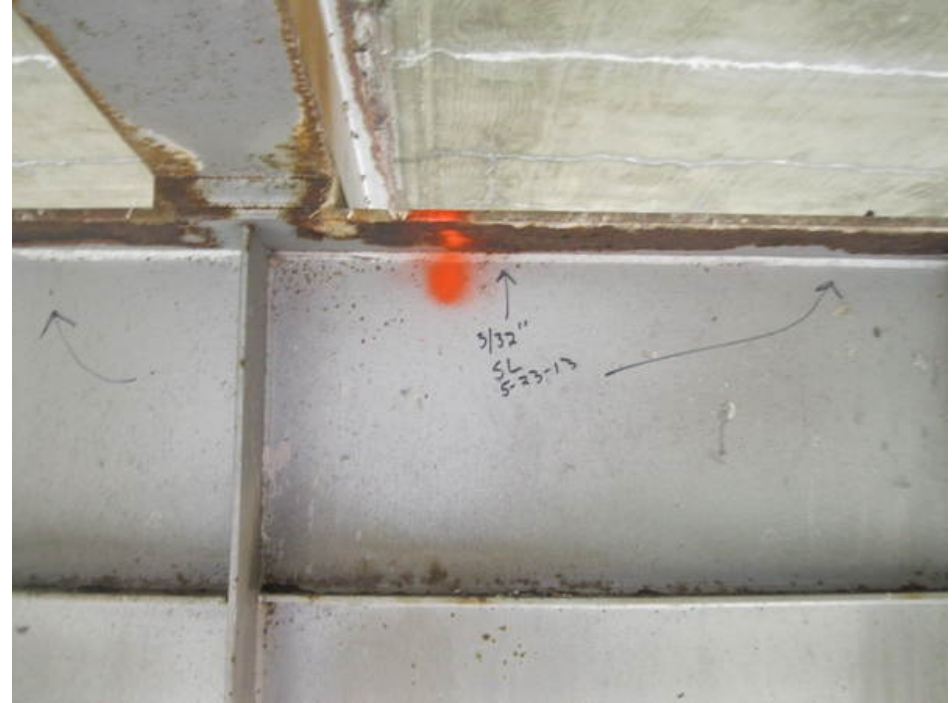
Bent 4 Span 3 S L

Section loss of 3/32" on the bottom of the top flange at bent 4 span 3. The top flange thickness is 1/2".

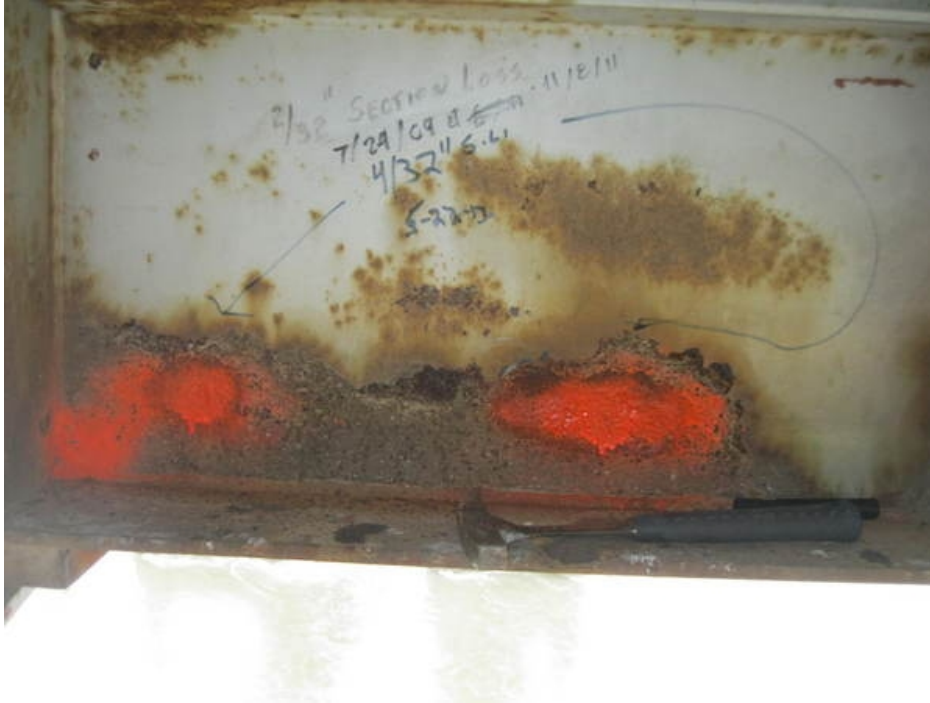
Bent 4 Span 3 S L

No changes noted to the 2 Spots of section loss of 4/32" on the web of the floor beam at bent 4 span 3 on the left between the jacking stiffener and the vertical stiffener.

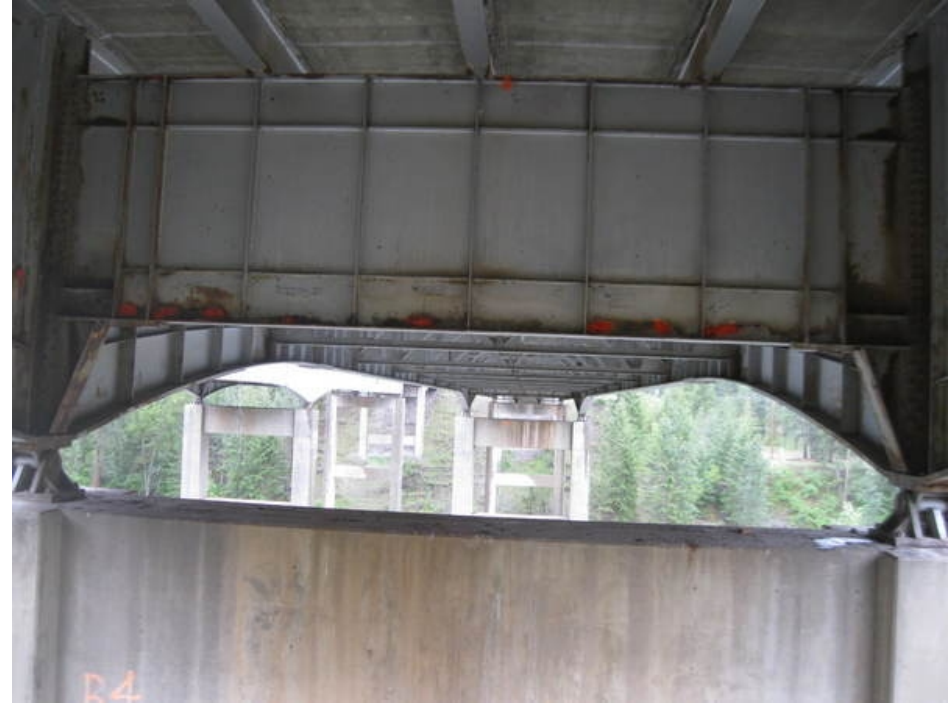
Bent 4 Span 3 S L

Very little changes noted in the section loss on the floor beam at bent 3 span 3. There is 3 additional spots of section loss of 2/32" on the knee brace left, 3/32" on the bottom of the top flange near the center stringer and 5/32" on the top of the bottom flange on the left between the jacking stiffeners. The web thickness is 10/32" and the flange thickness is 1/2".

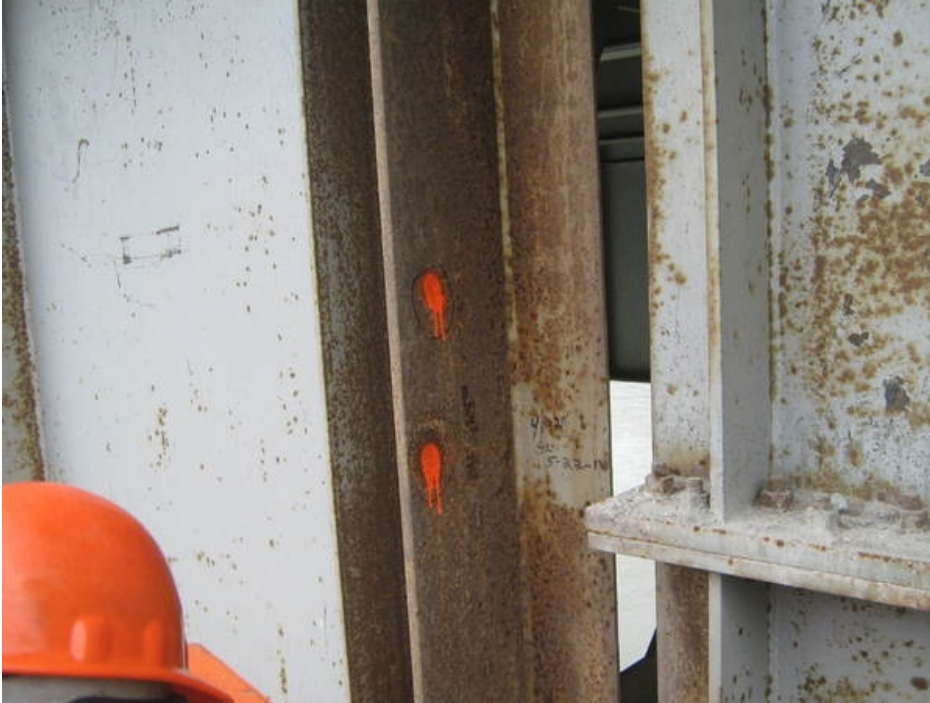
Bent 2 Span 3 SL

Section loss of 4/32" on the bearing stiffener at bent 2 span 3 on the right exterior girder. The web of the stiffener is 26/32" thick. This is in the main span.

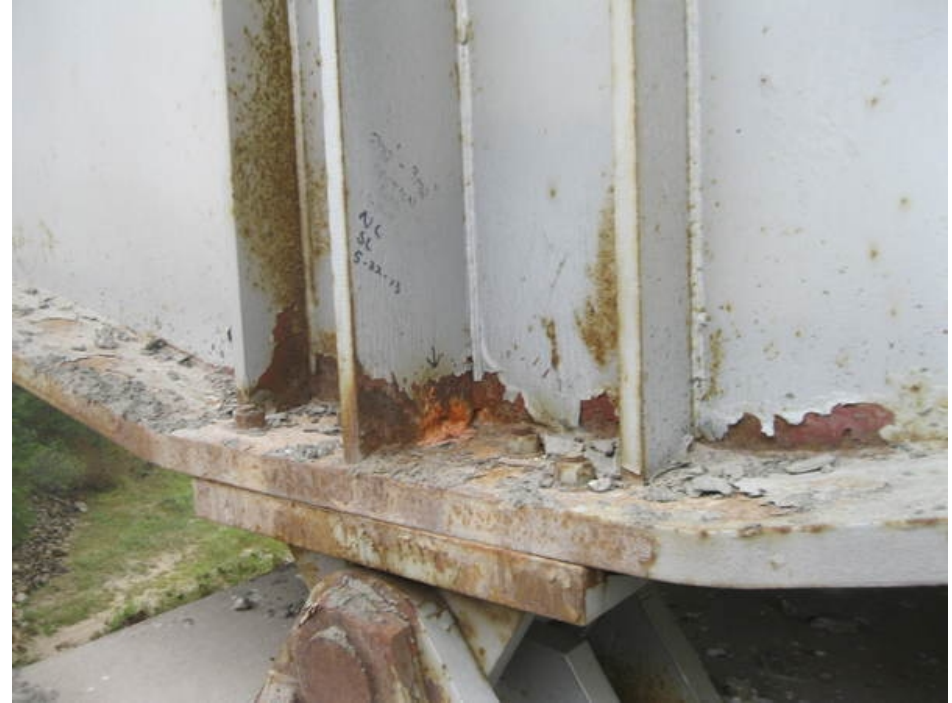
Bent 5 Left Girder

No changes noted in the 2/32"-3/32" section loss on the bearing stiffener at bent 5 left. The stiffener is 1" thick. This is in the main span.

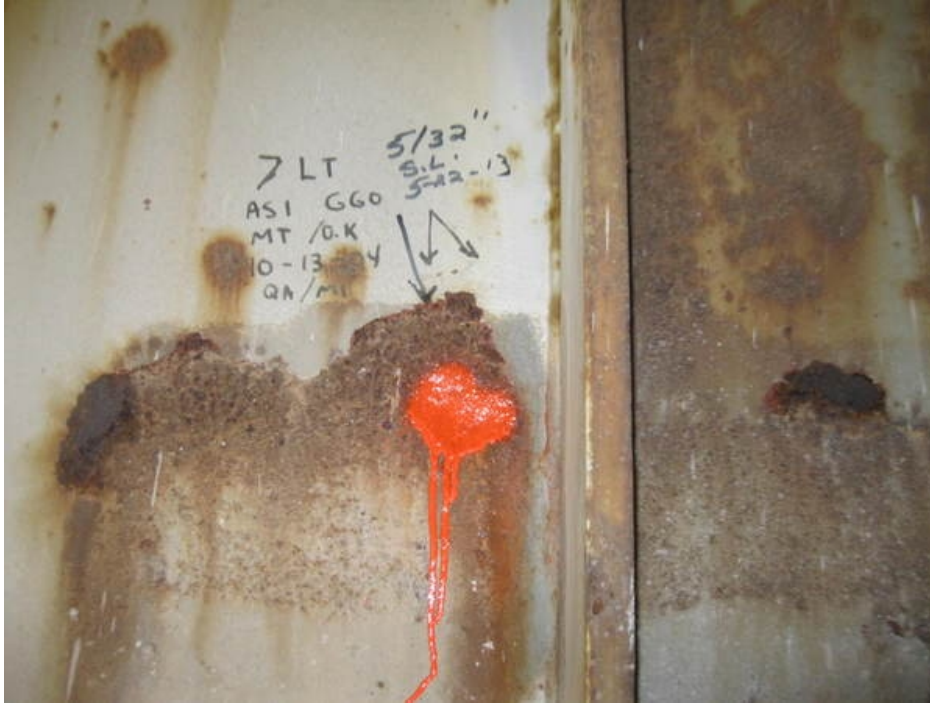
Bent 4 span3 S L

Section loss of 5/32" on the web of the left girder at bent 4 span 3 main span.

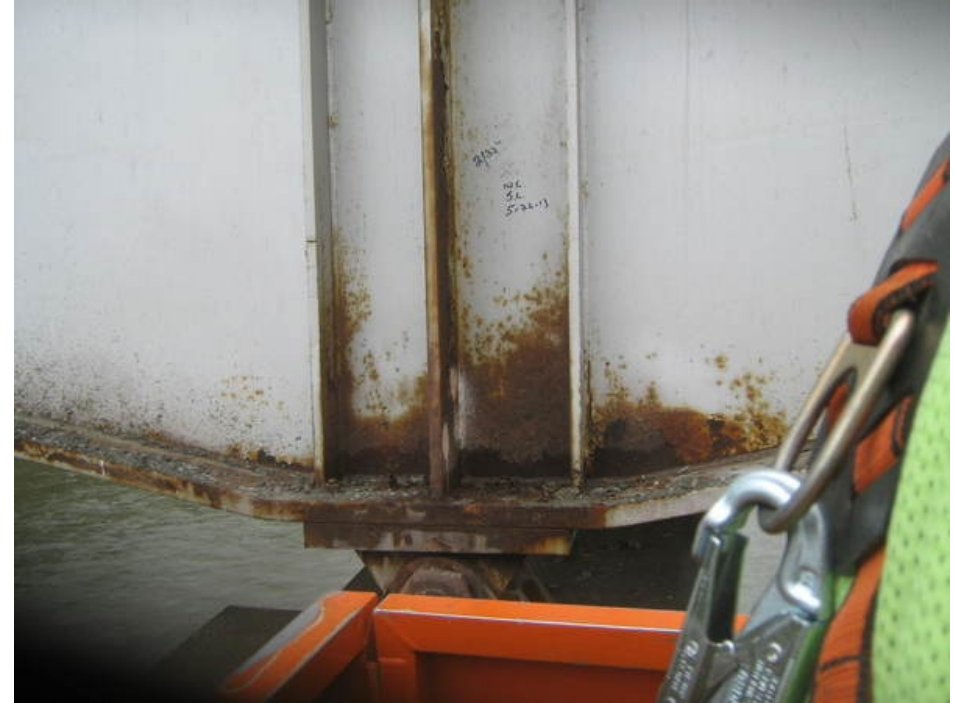
Bent 5 S L

No changes noted in the section loss of 2/32" on the web of the bearing stiffener at bent 5. The web thickness is 1".

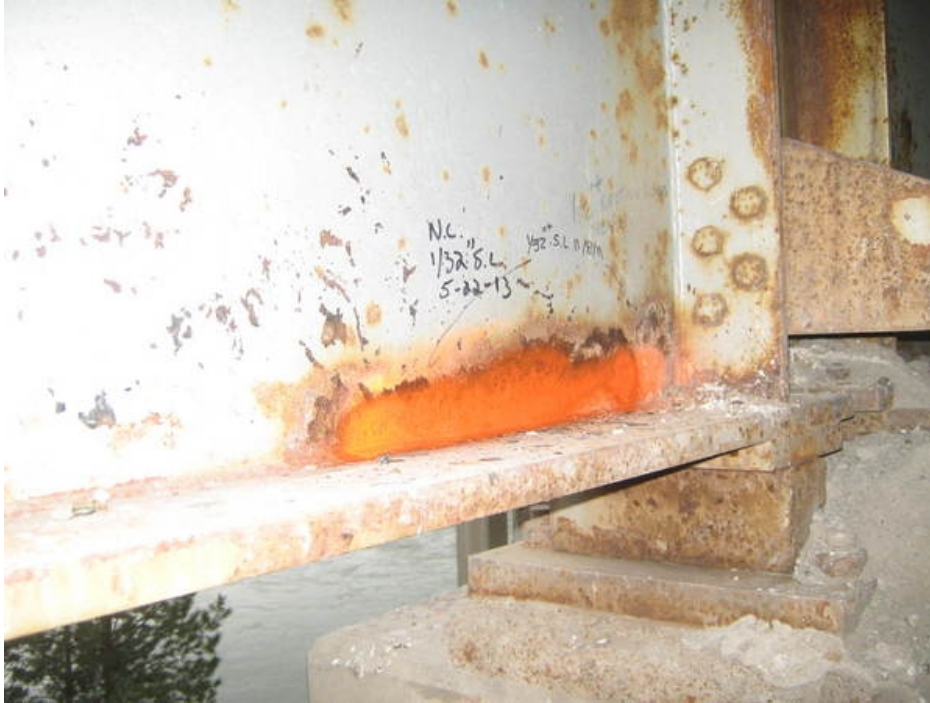
Bent 2 span 1 Right

No changes noted in the section loss of 1/32" on the right girder at bent 2 span 1.

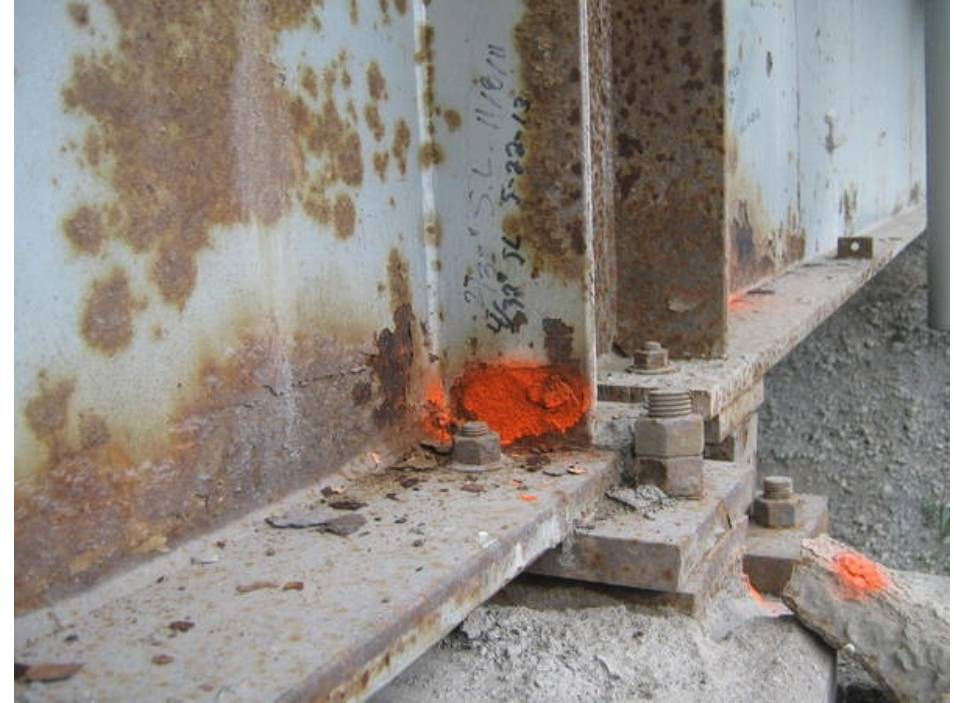
Bent 2 span 2 left

The section loss of 2/32" has increased to 4/32" on the left exterior web of the bearing stiffener that is 20/32" thick. Approach span.

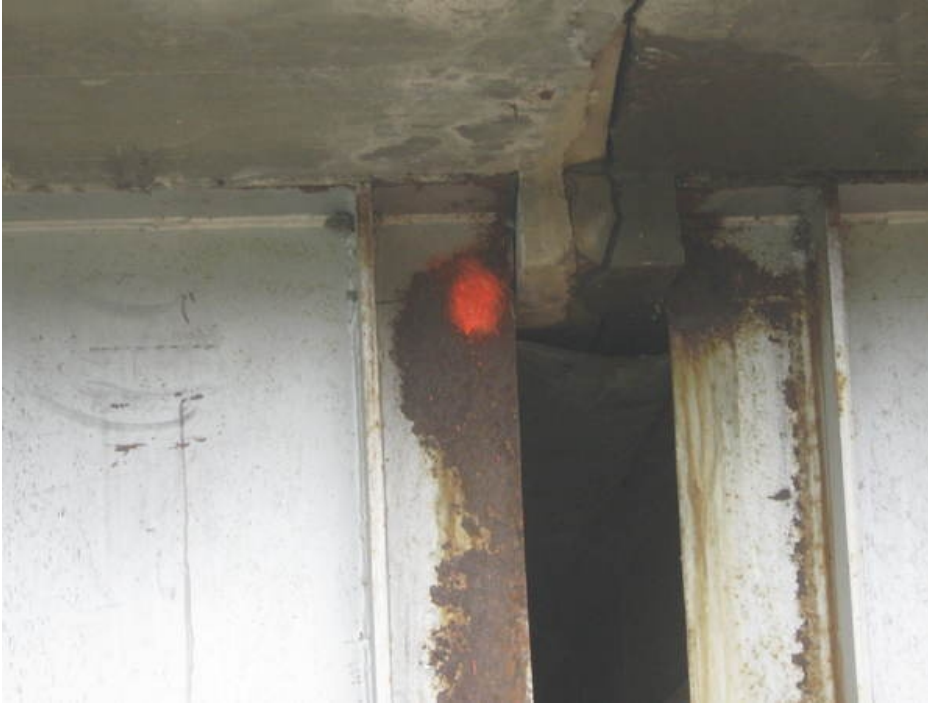
Bent 7 span 6 Right

No changes to the 3/32" section loss on the web of the girder. Approach span.

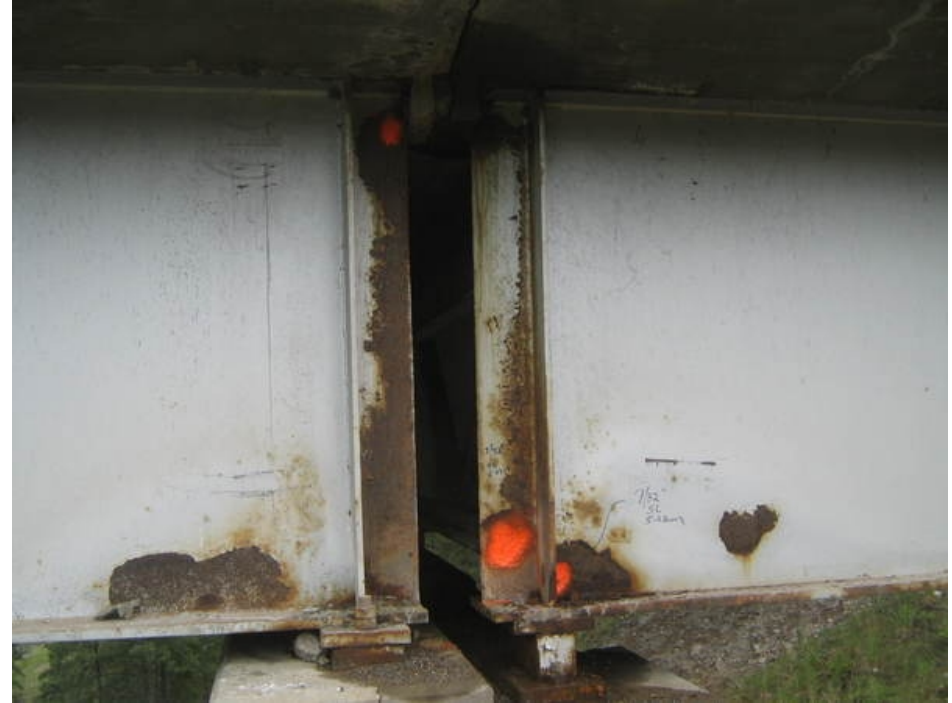
Bent 7 span 7 Right

2 spots of Section loss of 7/32" on the web of the right exterior girder. Approach span. Did not put pictures in BMS for all the unchanged section loss from previous inspection for approach spans and main spans.

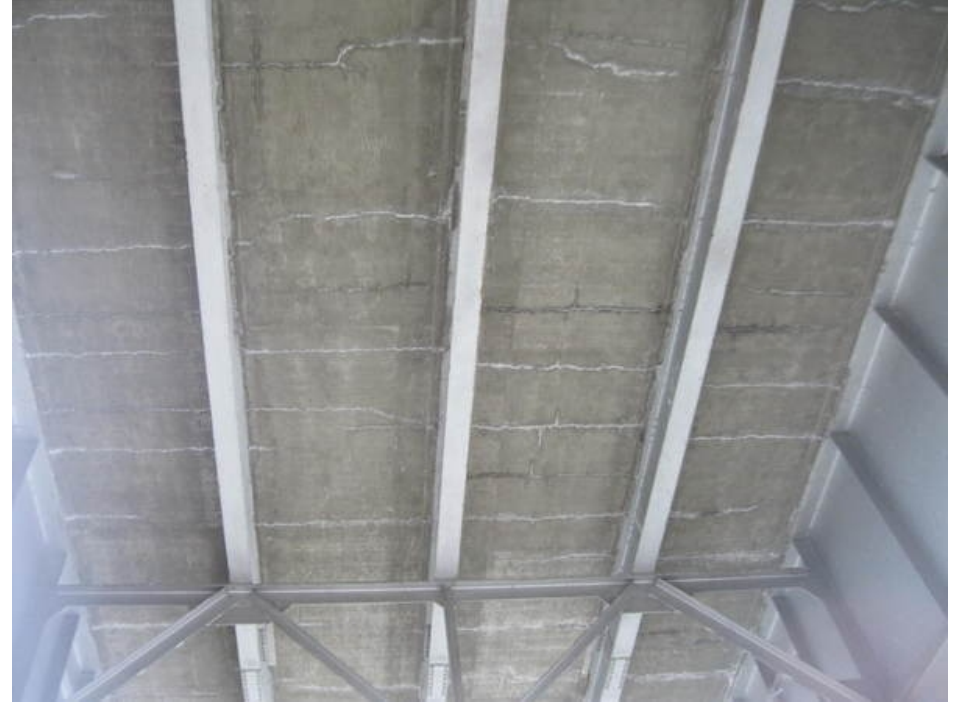
Soffit span 4

Heavy cracking with moisture leaking into the soffit.

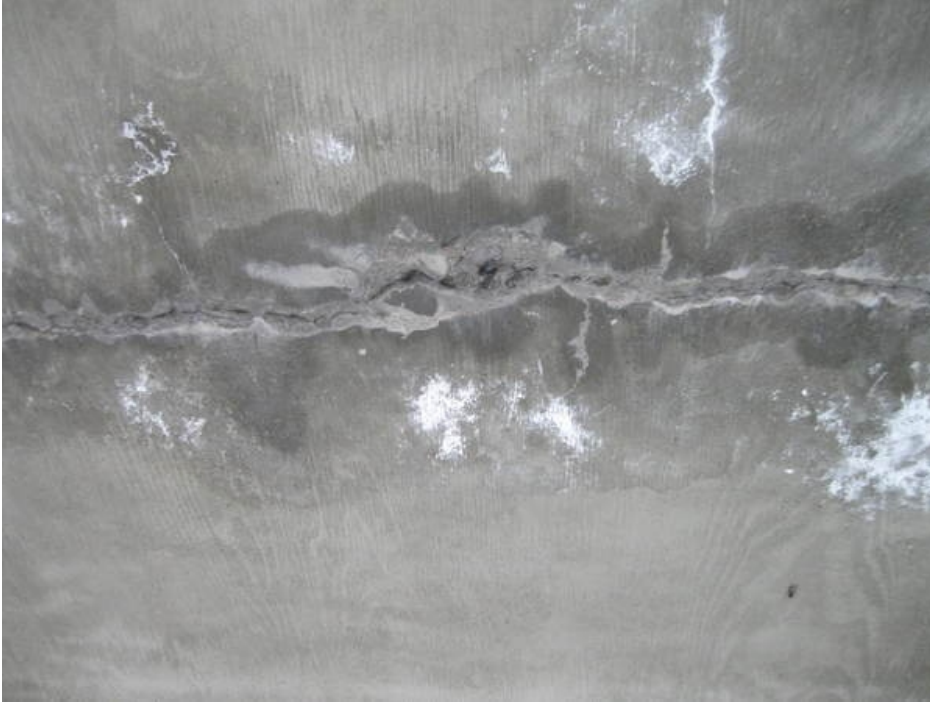
Soffit span 4

Large crack in the soffit with moisture and minor spalling.

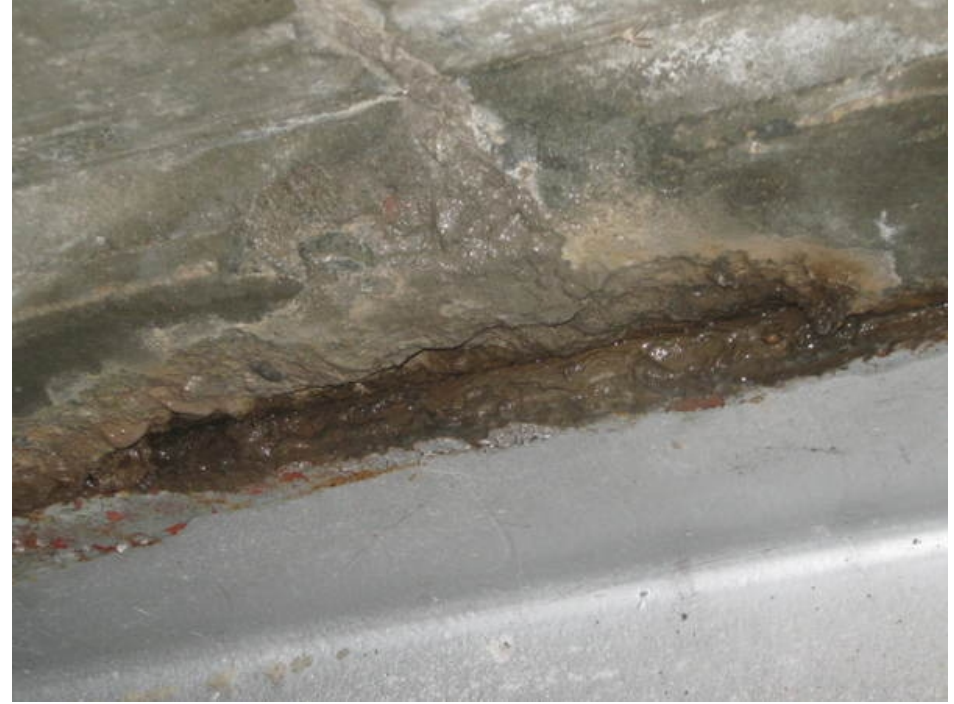
Stringer Span 3

Stringer span 3 with water seeping on the stringer. You can see water pumping out of crack when traffic drives over.

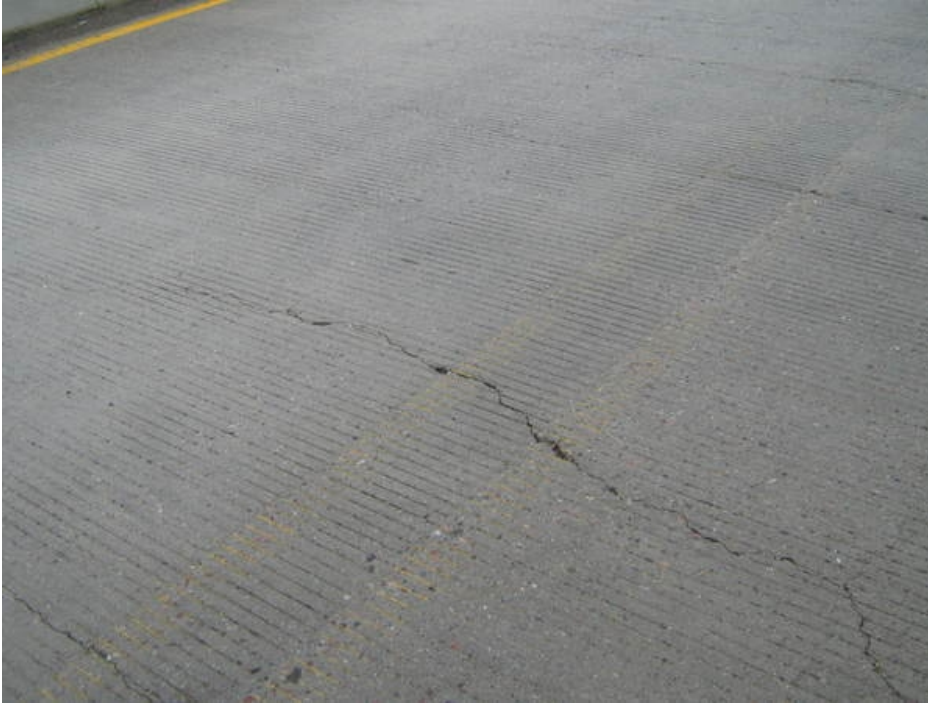
Deck Cracking

Deck cracking main spans. Large cracks is letting water seep into the soffit. The deck needs sealed.

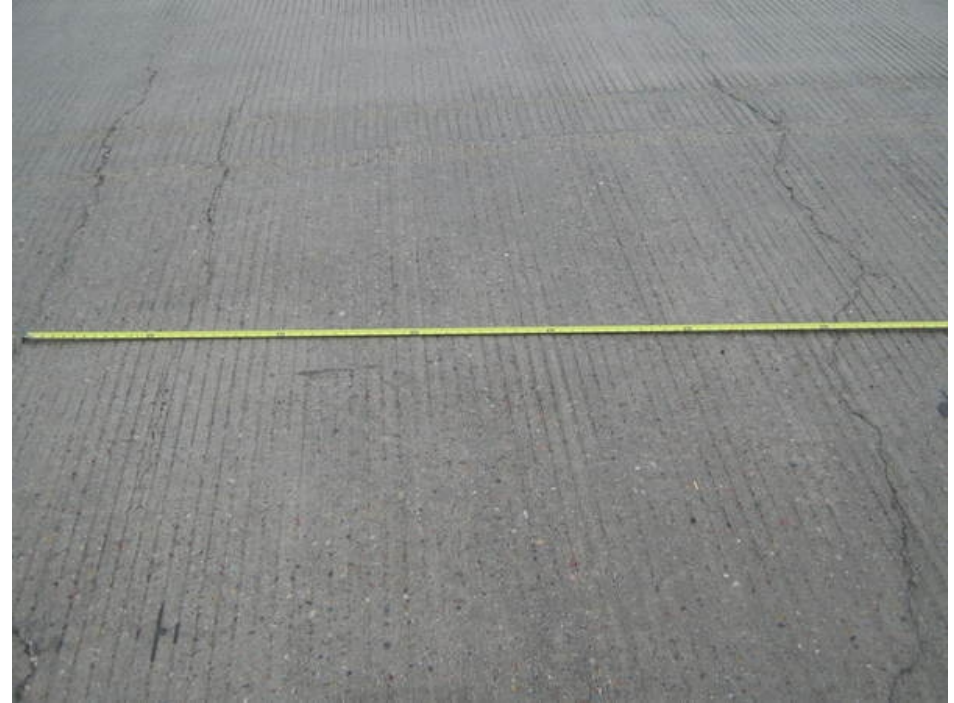
Deck Cracking

Deck cracking in the main spans. Deck needs to be sealed.
